Application News

High-Speed Video Camera

Observing the Fracture of Unidirectional CFRP in Static Tensile Testing

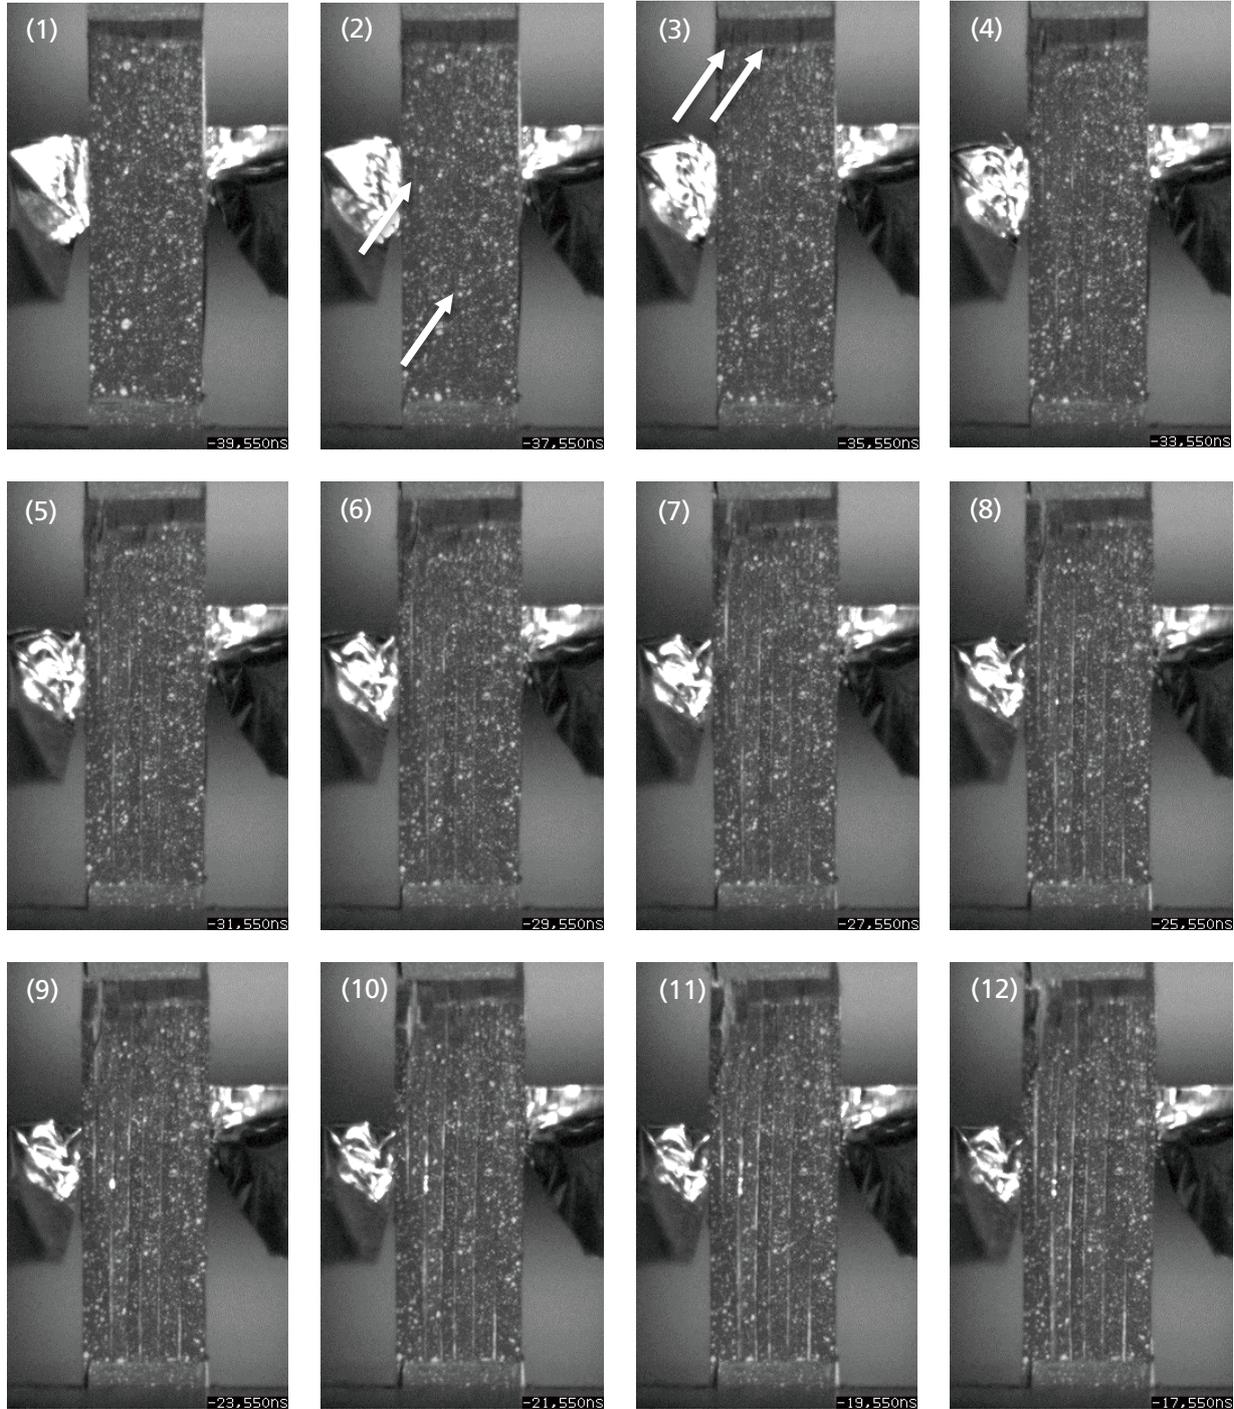
The failure of unidirectional CFRP is shown in Fig. 4. Longitudinal cracks can be seen on the left side of the specimen in image (2) of Fig. 4. In image (3), these cracks have propagated as far as the upper tab. Longitudinal cracks can also be seen on the right side of the sample in image (3). Image (6) is a later view of the sample as it is breaking apart. Using the HPV-X2 allows for the observation of CFRP failure during static tensile tests, which is useful for future CFRP development.

Fig. 4 Captured Images (Interval between captured images is 2 μ s.)
