Application News

No. V24M

High-Speed Video Camera

3D-DIC Analysis of CFRP Subjected to Collision with a High Speed Flying Object

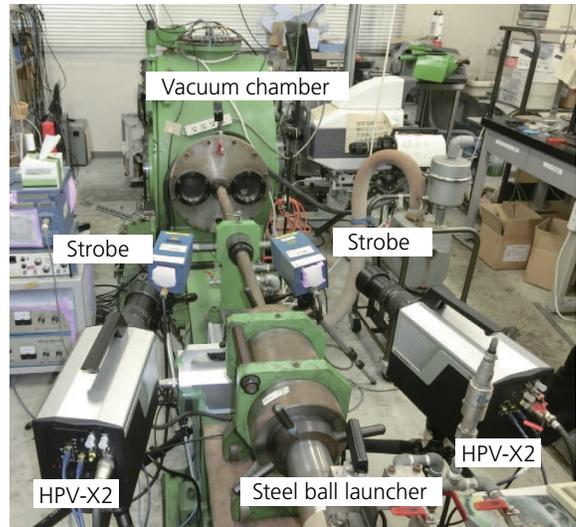
Fig. 1 Imaging System

Fig. 1 shows the imaging system, and Fig. 2 shows the interior of the vacuum chamber. A steel ball fired by a steel ball launcher collides with a CFRP specimen placed inside the vacuum chamber. Observation windows are positioned at the front of the vacuum chamber, on the left and right respectively. The collision with the steel ball is recorded through the observation windows by two HPV-X2 high-speed video cameras. The images obtained are subjected to 3D-DIC analysis utilizing VIC 3D (from Correlated Solutions), a DIC analysis program. The imaging equipment used is indicated in Table 1.
