Application News

High-Speed Video Camera

Fracture Observation and Observation of Strain Distribution of Plastic Material with Hole in Impact Compression Test

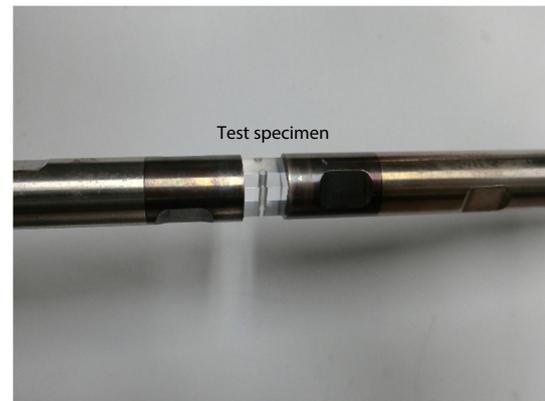
Fig. 2 Condition of Test Part

The fracture behavior of an acrylic block was observed using an HPV-X2 high-speed video camera. Table 1 shows the recording equipment. Fig.1 and Fig.2 show the conditions of recording and the test part, respectively. Illumination was provided by a Cavilux® laser light source (manufactured by Cavitar Ltd.). Use of the Cavilux system with the HPV-X2 can be considered an appropriate combination for high-speed recording, as the Cavilux is capable of outputting pulses as short as 20 ns in response to the shutter signals of the HPV-X2. The test specimen was an acrylic plastic block having a round hole with a diameter of 2 mm in its center. Table 2 shows the recording conditions. In this study, observation from the front face of the hole, observation from the side of the hole, and observation for use in the DIC analysis were carried out.
